***Edmonds Stream Inventory  
and Assessment***

***Edmonds, Washington***

***Final Report***

***July 29, 2002  
Pentec #12130-14***

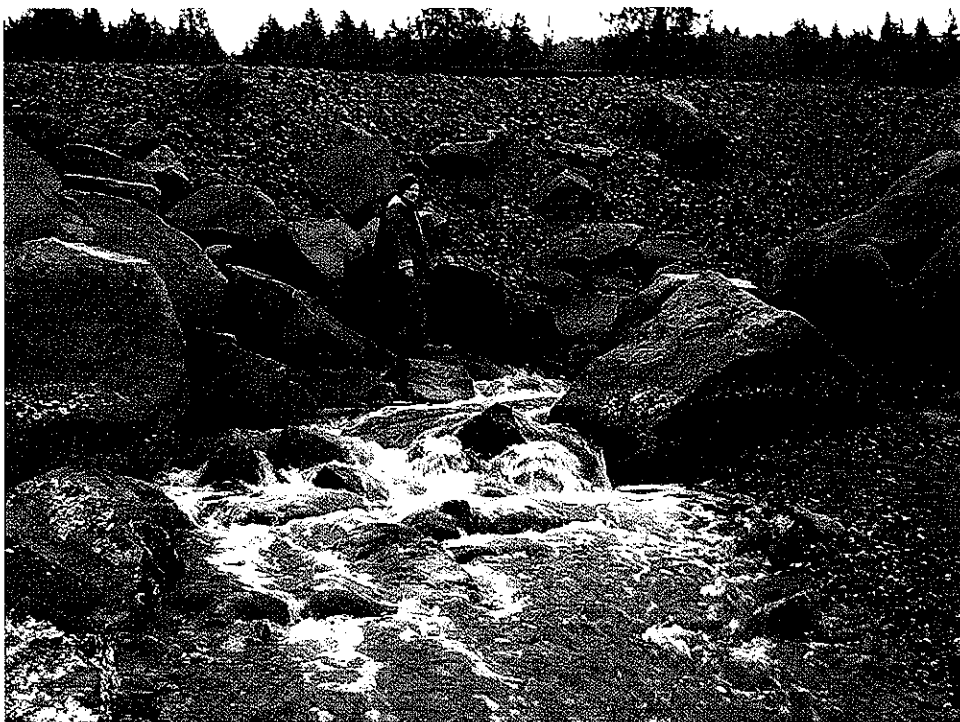
P-1 Perrinville Creek, downstream of culvert under BNRR tracks.

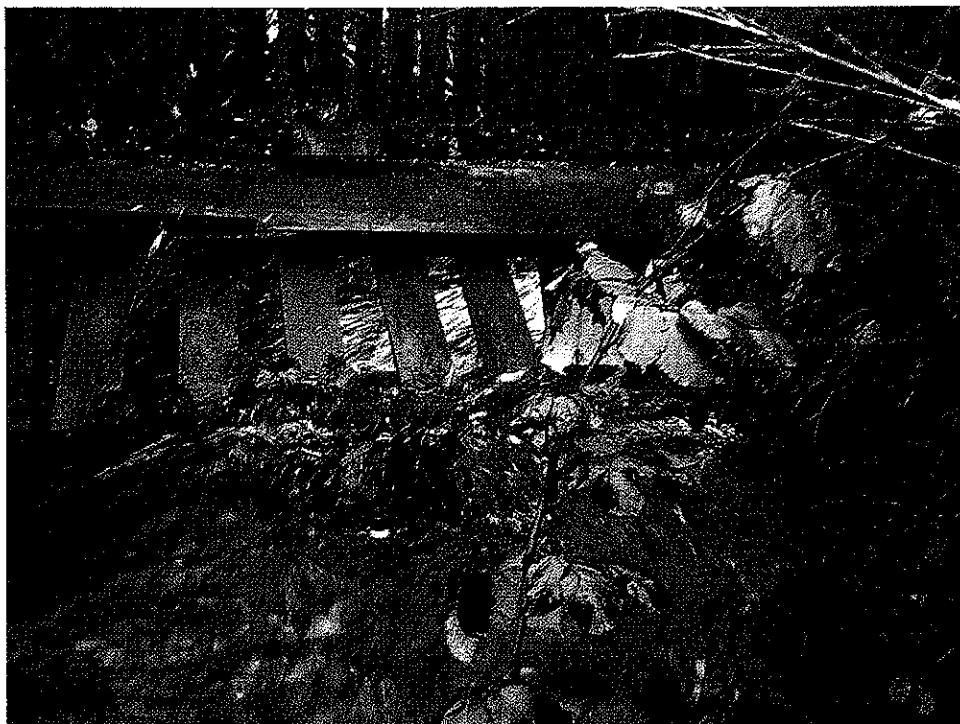
P-2 Perrinville Creek, fence across channel upstream from mouth.

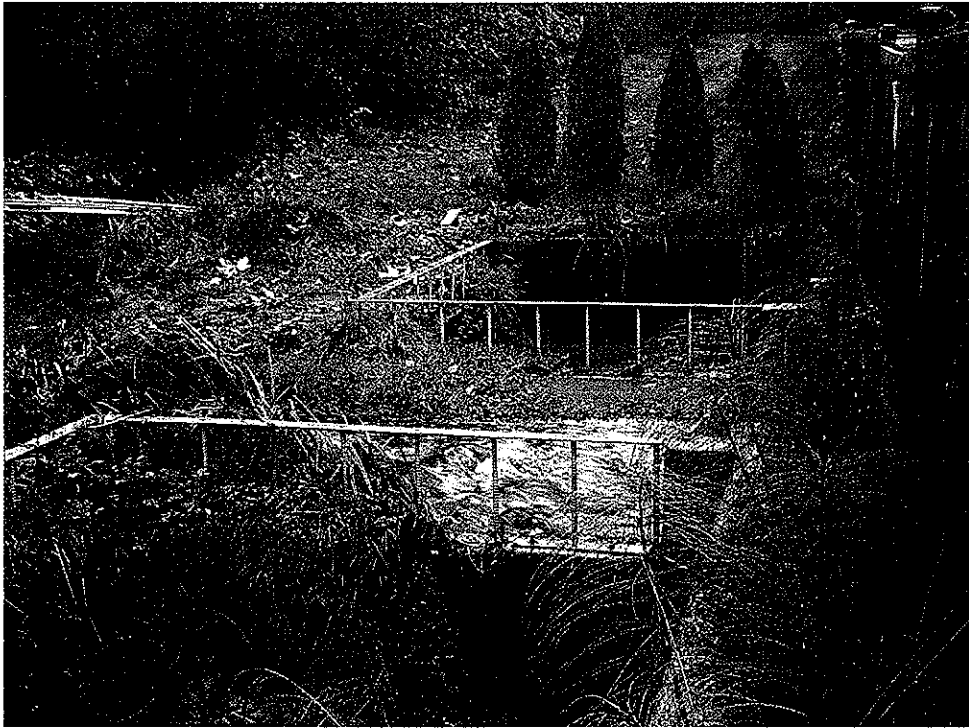
P-3 Perrinville Creek stormwater overflow.

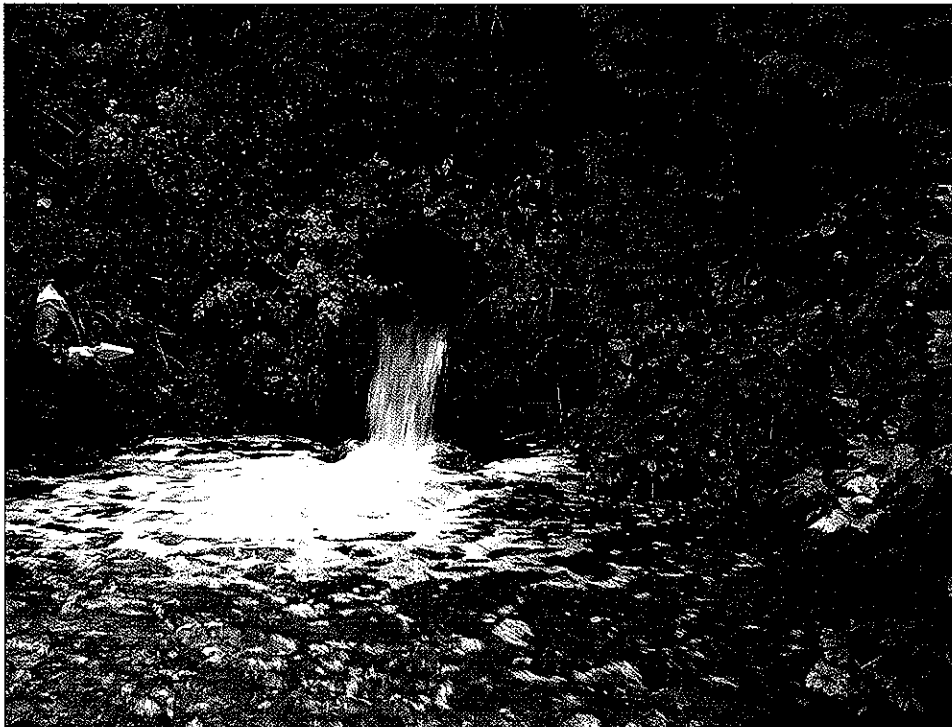
P-4 FB5 – Perrinville Creek, downstream of culvert under Talbot Road.

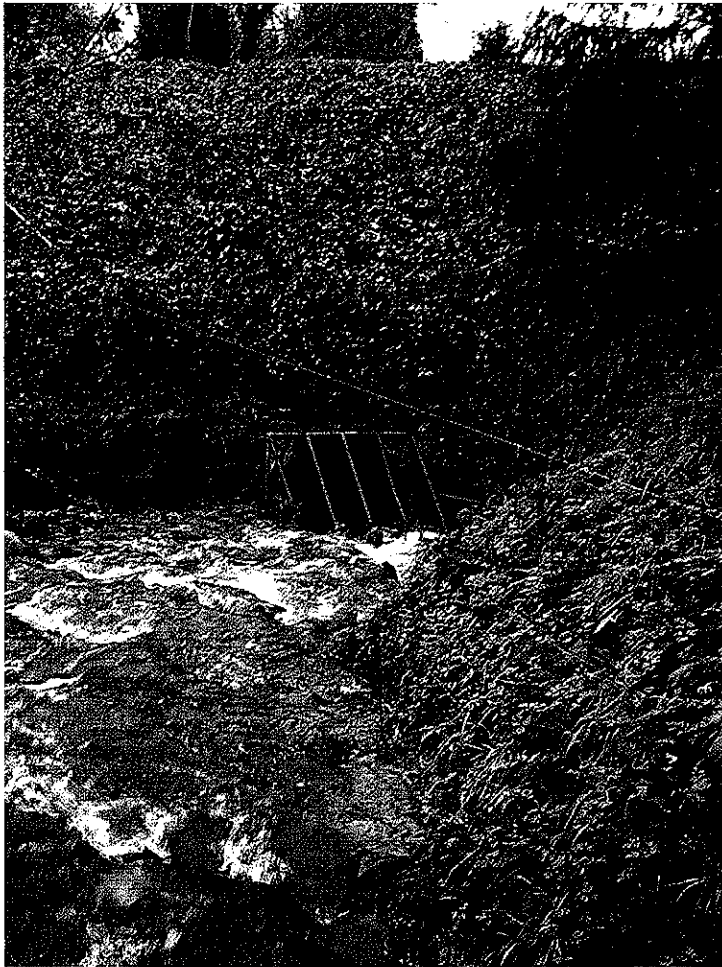
P-5 Inlet to culvert under Talbot Road (11/14/01).

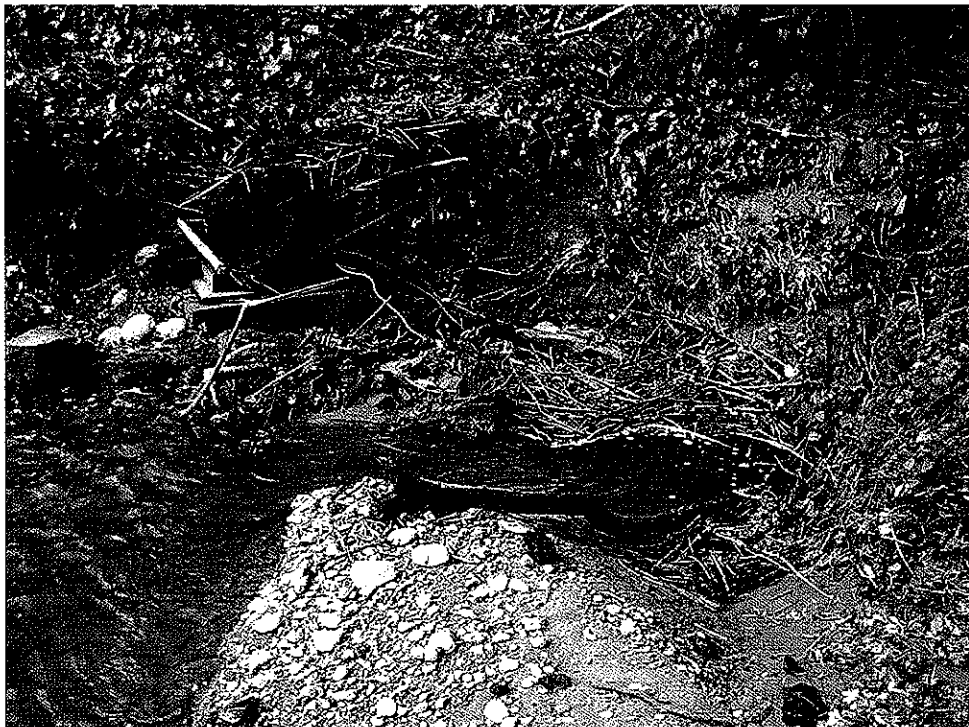
P-6 Clogged culvert inlet at Talbot Road (12/17/01).

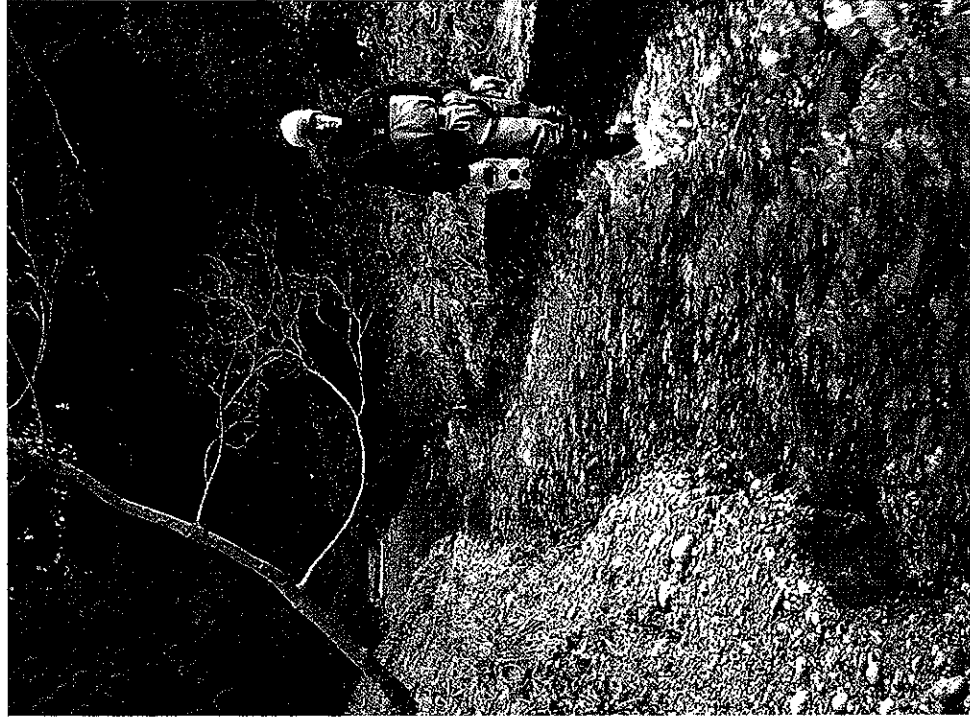
P-7 Eroded stream channel above Talbot Road (12/17/01).

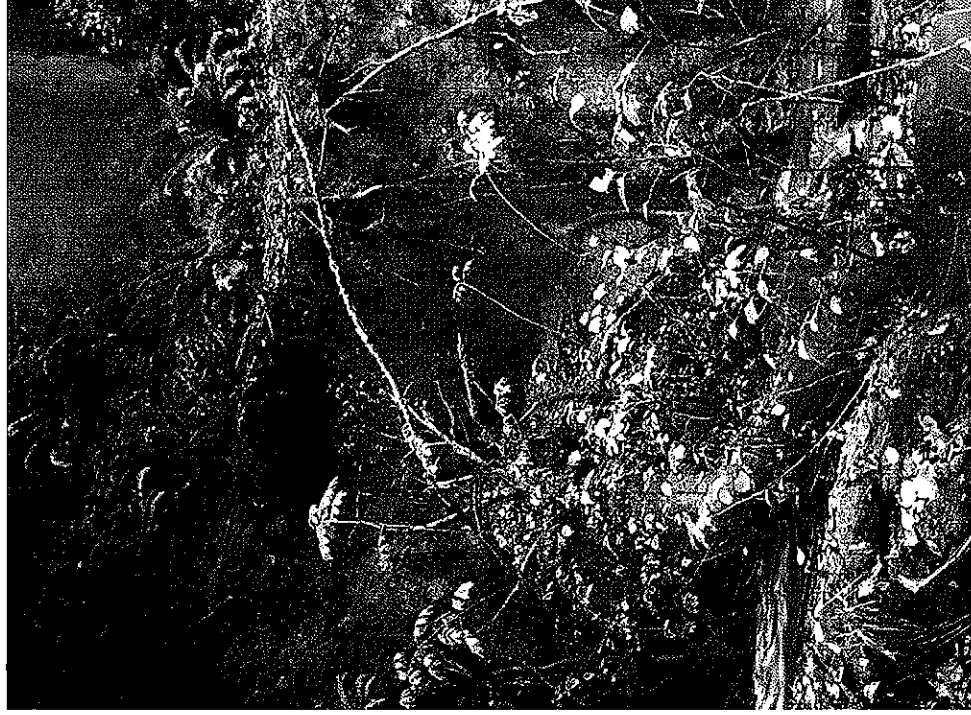
P-10 Perrinville Creek, streambank erosion in Southwest County Park.

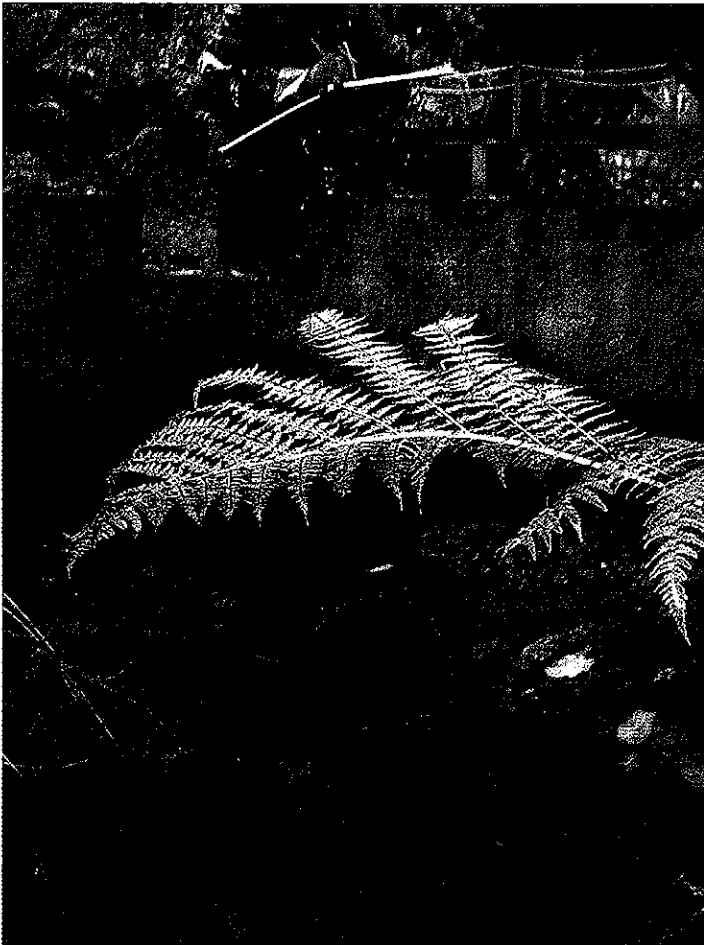
F-4 Fruitdale Creek, flood control structure upstream of Sound View Place.

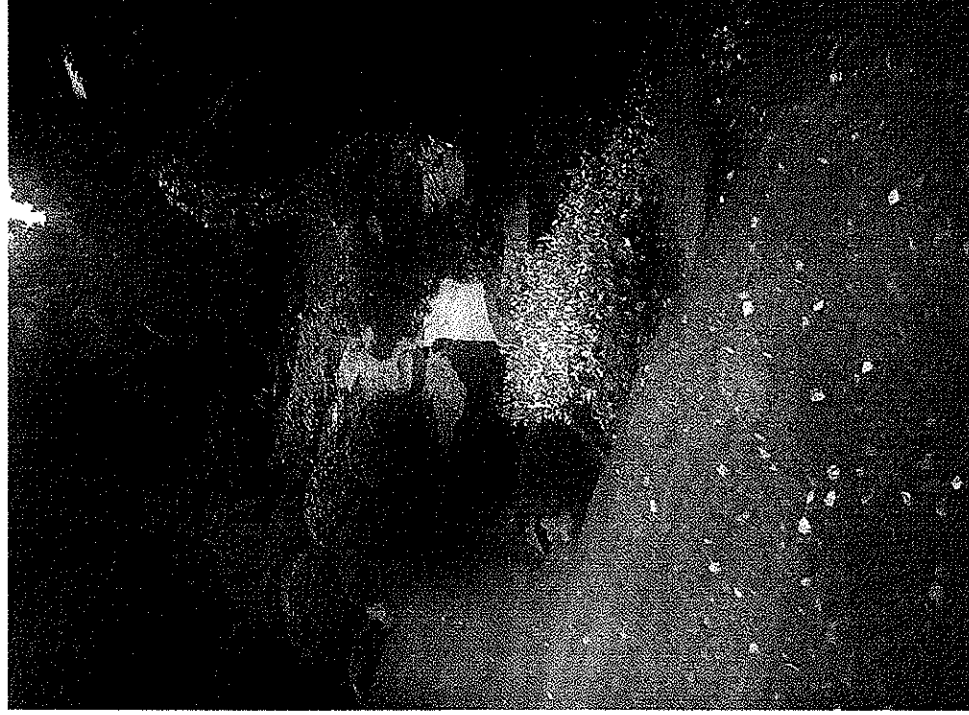
F-6 Fruitdale Creek, modified stream channel.

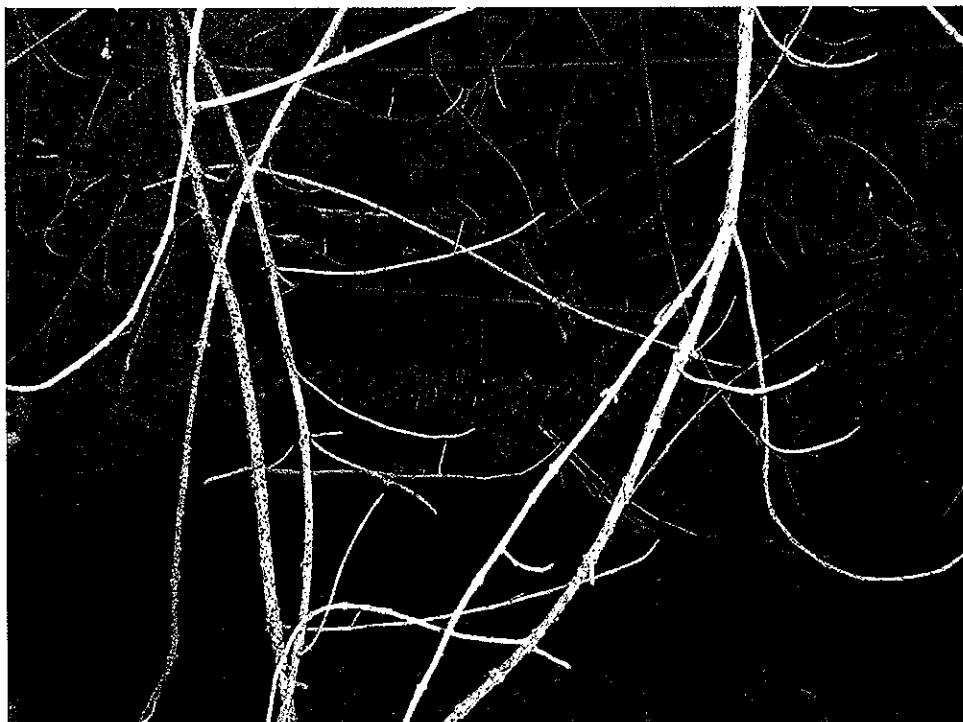
S-5 Shell Creek, fence across channel.

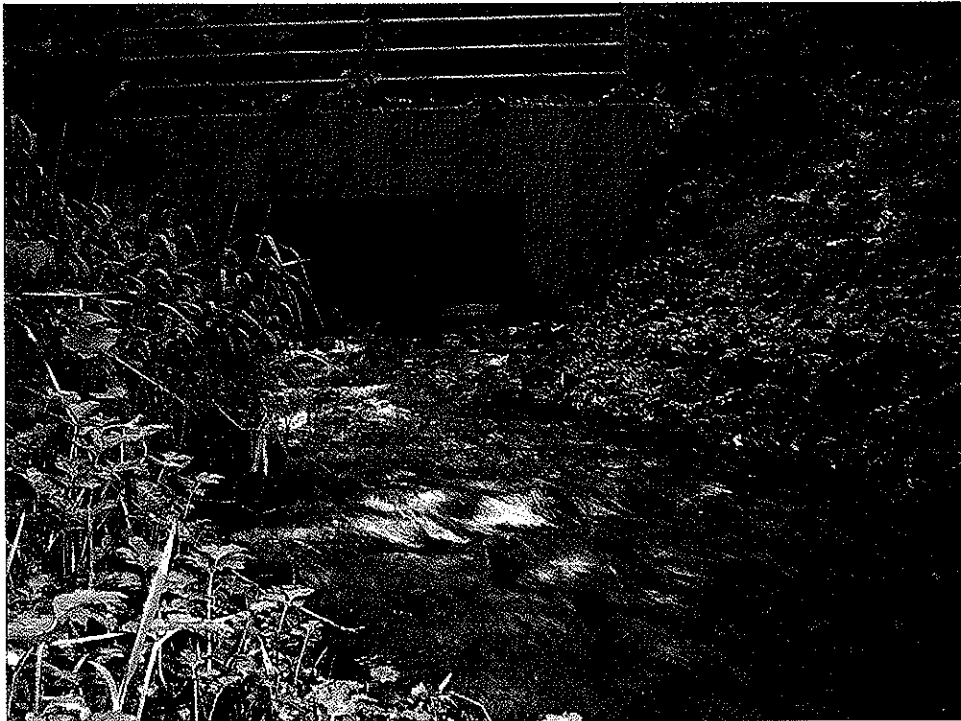
S-7 Shell Creek, culvert under Daley Street.

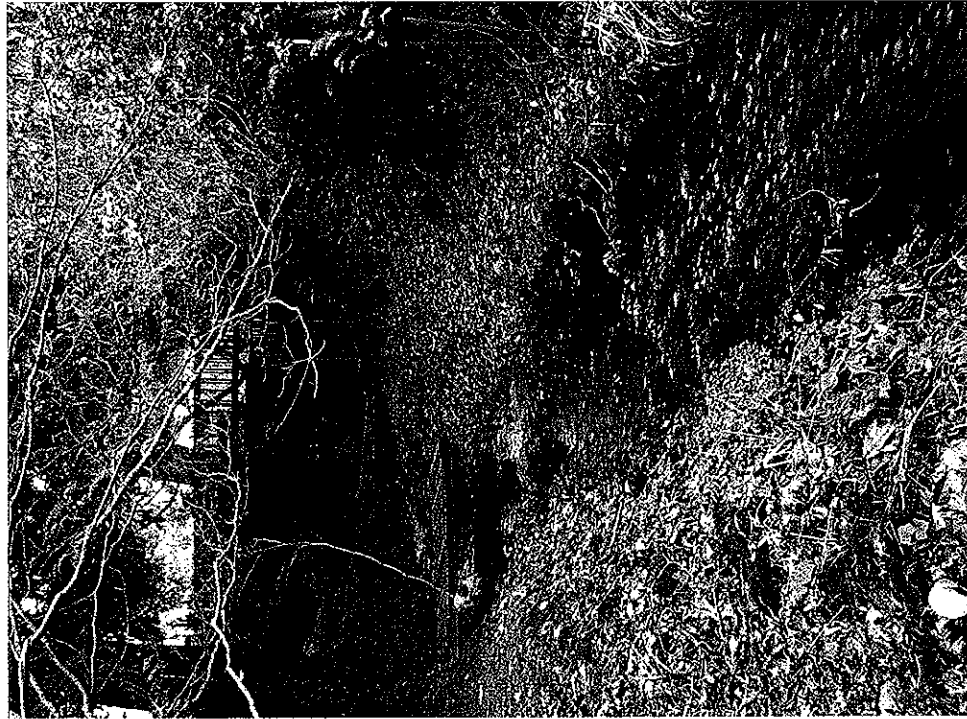
H-1 Hindley Creek, impassable barrier,  
upstream of Brookmere Drive.

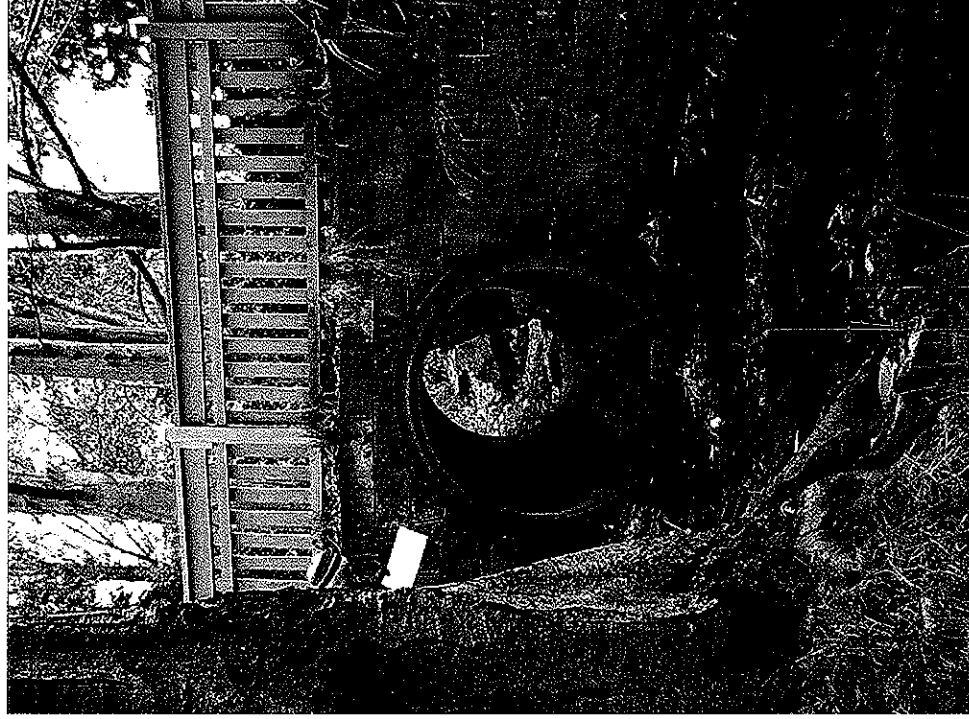
H-3 Hindley Creek, culvert under driveway to Hindley Lane.

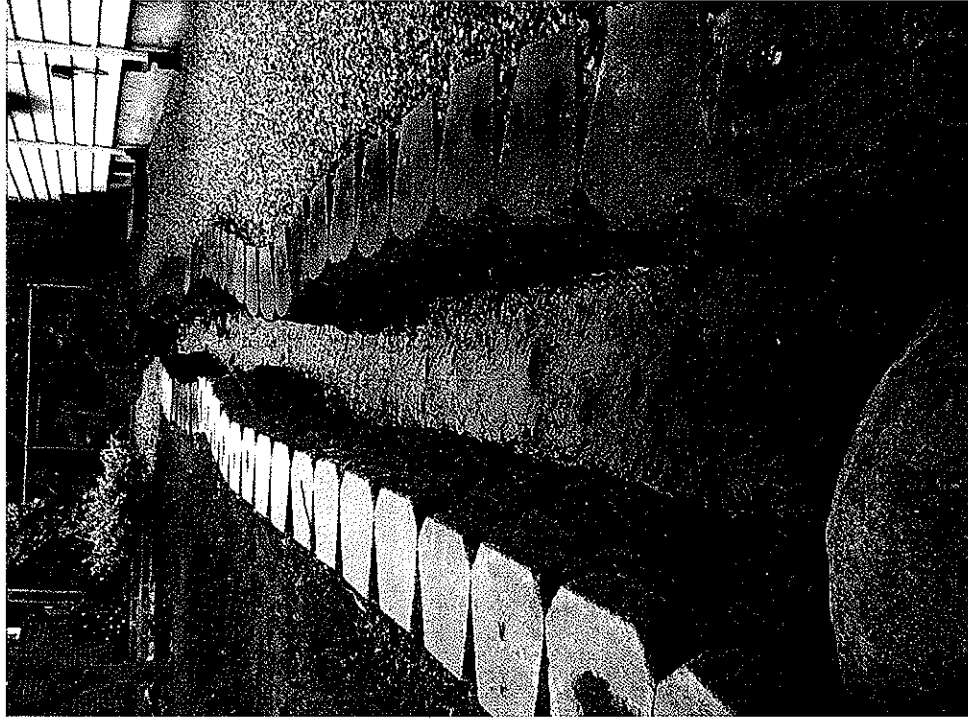
SB-9 Shellabarger Creek, modified channel,  
north fork.

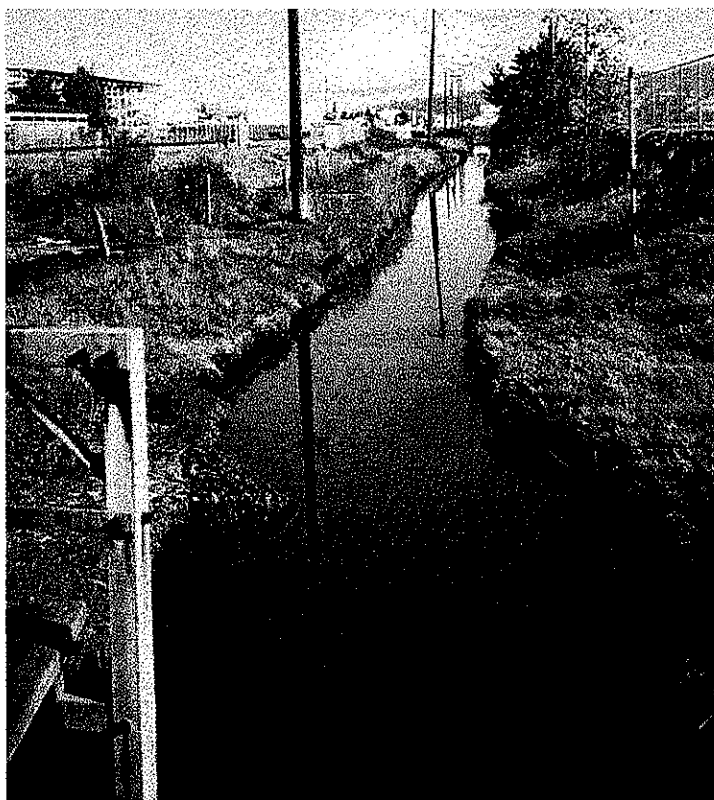
W-2 Channelized lower portion of creek along Admiral Way (10/20/98).
